Development of Surface Treatment VACAL[®]-Z for Vacuum Equipment Using Corrosive Gases

We have developed a method of micro arc oxidation treatment (VACAL[®]-Z) as a surface treatment for aluminum alloy used in vacuum equipment using corrosive gases, such as CVD equipment. The oxide layer formed by VACAL[®]-Z had a three layer structure of crystalline γ -alumina. In addition, we have devised and made possible a step processing method for treating the entire surface of large objects, such as vacuum production equipment for flat panel displays, by VACAL[®]-Z.

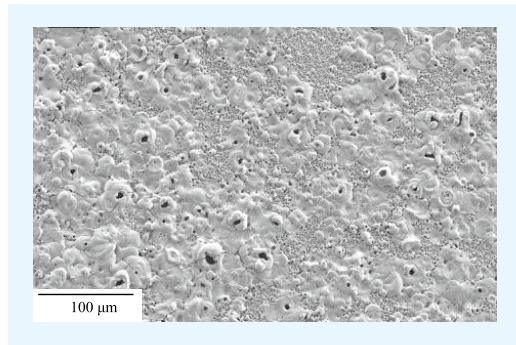
Fig. 3-1 shows a surface scanning electron microscope (SEM) image of the VACAL®-Z treated sample. The surface of the VACAL®-Z treated sample has a bumpy, lava-like morphology. In addition, since the electrolytic treatment is accompanied by spark discharge, which is a feature of MAO treatment, there are holes of several μm in size across the entire surface. Fig. 3-2 shows a cross-sectional SEM image

Fig. 3-1 Surface SEM image of VACAL®-Z oxide film

sample as a result of the heating and cooling, and there was no change in the surface morphology shown in Fig. 3-1. It is generally known that Alumite cracks when heated due to the difference in the coefficient of linear expansion between the base metal and the Alumite³⁾. This phenomenon applies to VACAL[®]-Z treatment as well. However, the reason why heating and cooling did not cause cracking in the oxide film formed by VACAL[®]-Z treatment is thought to be due to the stress relaxation caused by the distribution of voids of several hundred nm to several μm throughout the oxide film.

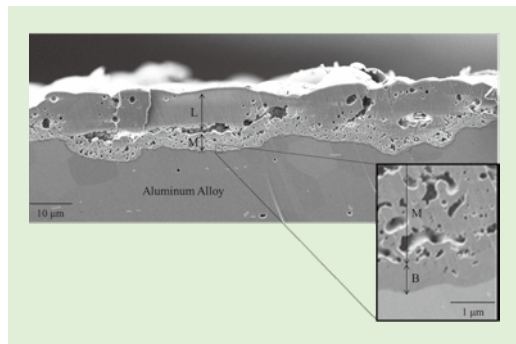
Fig. 3-2 Cross sectional SEM image of VACAL®-Z oxide film (L: Lava layer, M: Micro pore layer, B: Barrier layer)

of the VACAL®-Z treated sample. The film thickness varies from location to location and ranges from 10 to 17 μm. The oxide film formed by VACAL®-Z treatment has a three-layer structure. Starting from the outer surface, there is a lava-like layer with a thickness of less than 10 μm; a micro pore layer with a thickness of a few μm, containing small voids up to a few μm in size; and a barrier layer with a thickness of a few hundred nm formed at the interface with the base metal. The oxide film formed by VACAL®-Z treatment has voids of several hundred nm to several μm in size, but there are no voids or cracks extending from the surface to the base metal.

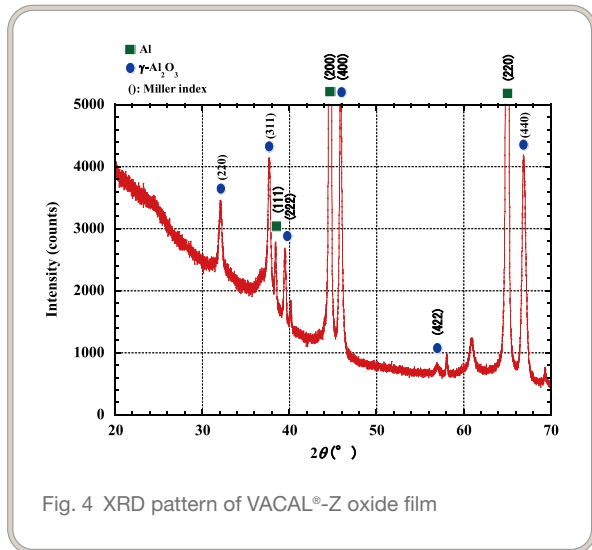
Fig. 4 shows the results of X-ray diffraction (XRD) measurements of the VACAL[®]-Z treated sample. Peaks of $\gamma\text{-Al}_2\text{O}_3$ were detected in the oxide film formed by VACAL[®]-Z treatment, indicating the growth of a crystalline oxide film. Since Alumite is an amorphous oxide film, no Al_2O_3 peaks

were detected in the XRD measurements.

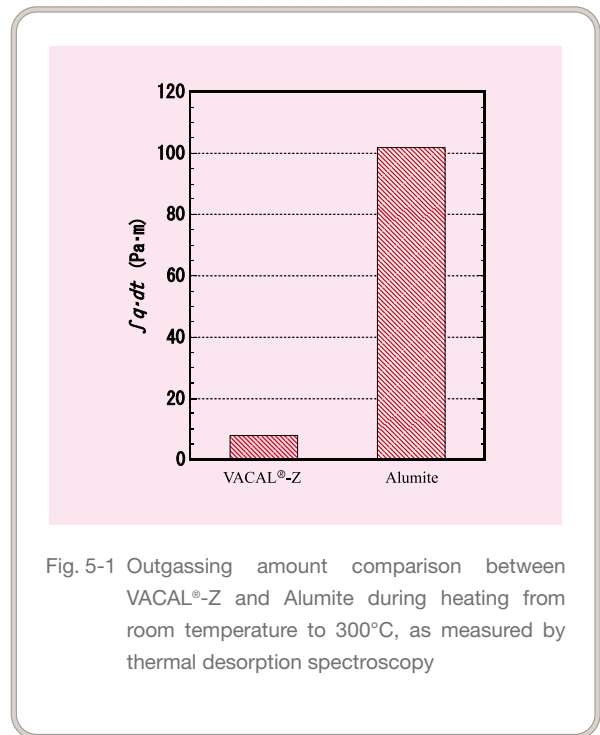
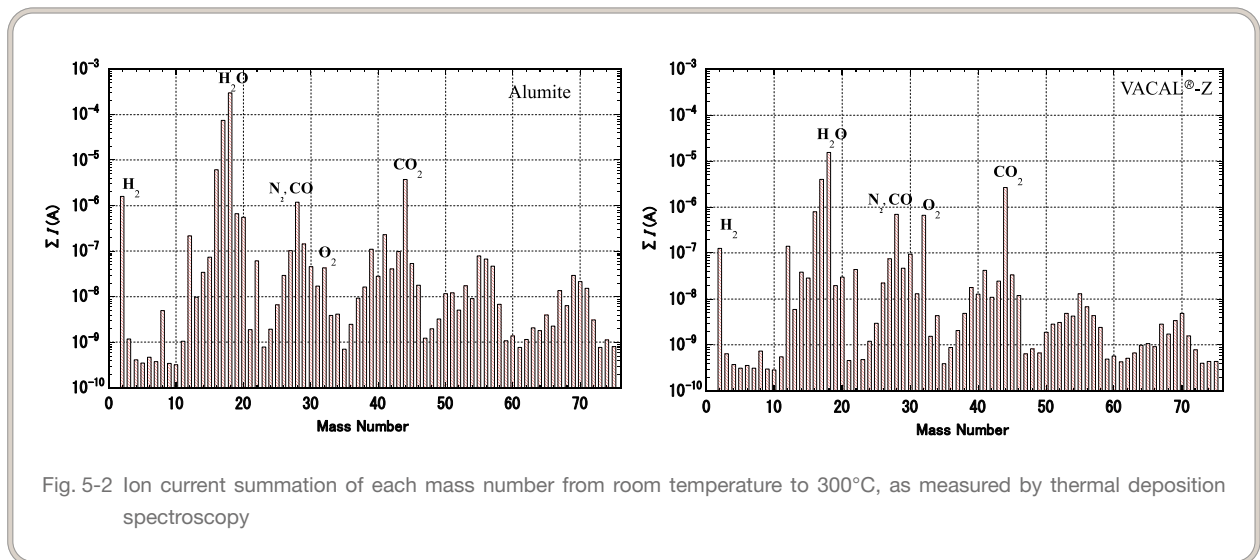
Fig. 5-1 shows the amount of outgassing per unit area during heating from room temperature to 300°C. The amount of outgassing from the VACAL[®]-Z treated sample was no more than 1/10 of the amount from an Alumite sample. Fig. 5-2 shows the ion current summation value of each gas released from the VACAL[®]-Z treated sample and the Alumite sample from room temperature to 300°C. The main gases outgassing from the VACAL[®]-Z treated sample were hydrogen, water, nitrogen, carbon monoxide, oxygen,

and carbon dioxide, and water being the most commonly released gas. In terms of water release, the VACAL[®]-Z treated sample had an ion current summation value of about 1/10 that of the Alumite sample. This is thought to be due to the lack of fine holes like those in the Alumite sample and the lack of hydrate formation. In addition, the VACAL[®]-Z treated sample had a higher ratio of carbon dioxide and oxygen than the Alumite sample did. The large amount of carbon dioxide outgassing is thought to be due to the release of electrolyte anions incorporated in the oxide film. A large amount of oxygen was released because the electrolytic treatment was performed at a high voltage and a high current density, and as a result significant quantities of oxygen ions were incorporated into the oxide film.

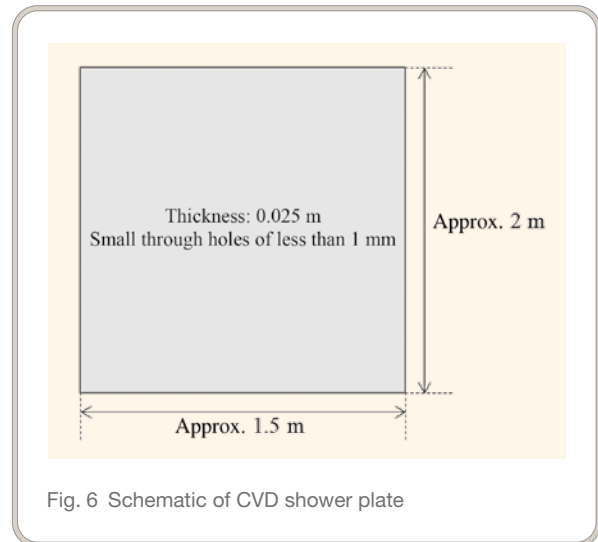
Fig. 6 Schematic of CVD shower plate

The CVD shower plate shown in Fig. 6 was prepared as the evaluation sample. This shower plate was subjected to step processing four times to treat the entire surface. In addition to the above, to verify that there are no problems on morphology or composition, we obtained a 500 mm × 1000 mm × 3 mm sheet of aluminum alloy A6061 and prepared a sample that underwent the same step processing.

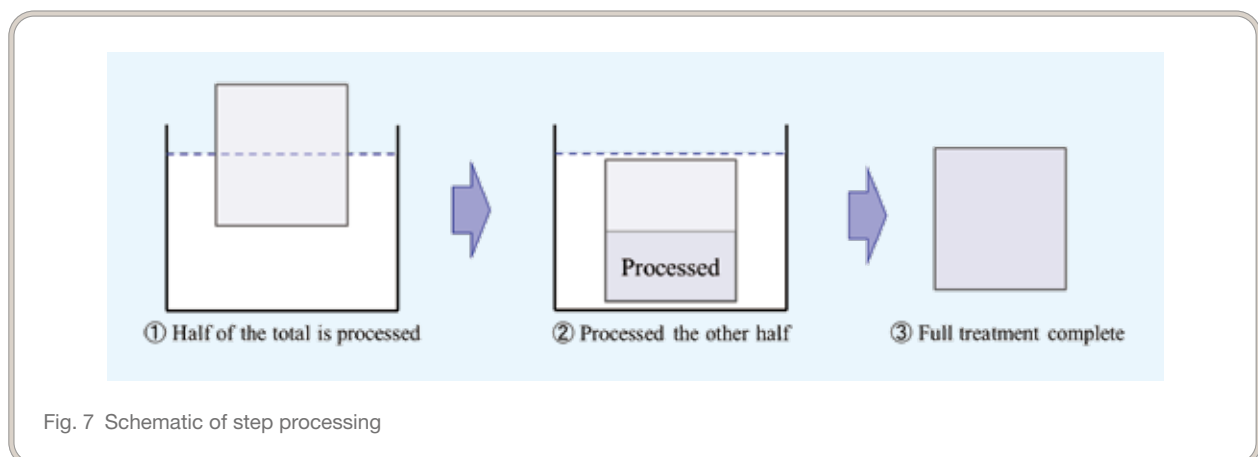
Fig. 7 Schematic of step processing

Fig. 7 shows the procedure for step processing. The procedure shown here is for the case where the treatment of the entire surface is done in two steps. First, in order to treat half of the whole, half is immersed in the electrolytic solution and subjected to VACAL[®]-Z treatment. Next, in order to treat the remaining half, the entire surface is immersed and subjected to VACAL[®]-Z treatment. Since the VACAL[®]-Z treatment only grows an oxide film with a film thickness proportional to the treatment voltage, the oxide film does not grow above the film thickness determined by the treatment voltage. In other words, this method utilizes the fact that electrolytic treatment is preferentially performed in areas where the oxide film has not yet been formed. The method and step processing we devised ensure uniform VACAL[®]-Z treatment over the entire surface of the target.

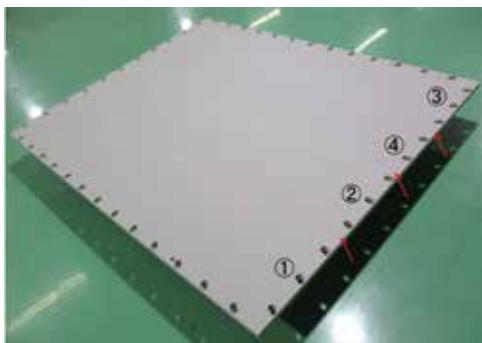
Fig. 8-1 shows a photograph of the CVD shower plate for

Fig. 8-1 Photograph of VACAL[®]-Z treated shower plate

which the entire surface was treated by step processing. The numbers in the photograph indicate the order (1, 2, 3, 4) in which the step processing was performed. Visual inspection revealed black streaks at the locations corresponding to the liquid surface of the electrolytic solution (red arrows), however an oxide film was formed on the entire surface. Fig. 8-2 shows the results of measuring the thickness of the oxide film using an eddy current film thickness gauge. The numbers in the photograph indicate the thickness of the oxide film at different locations, ranging from 13 to 15 μm. An oxide film of approximately the same thickness was formed at each step. Fig. 9 shows cross sectional SEM images of the first step and the border where the black streak appeared, and Table 1 shows the results of the component analysis of the oxide film performed by EPMA qualitative analysis. The results show that the border region formed by the step processing had an oxide film that was morphologically and compositionally equivalent to that of other regions.

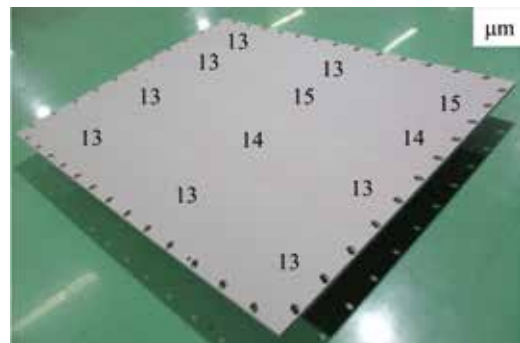
Fig. 8-2 Oxide film thickness of VACAL[®]-Z treated shower plate

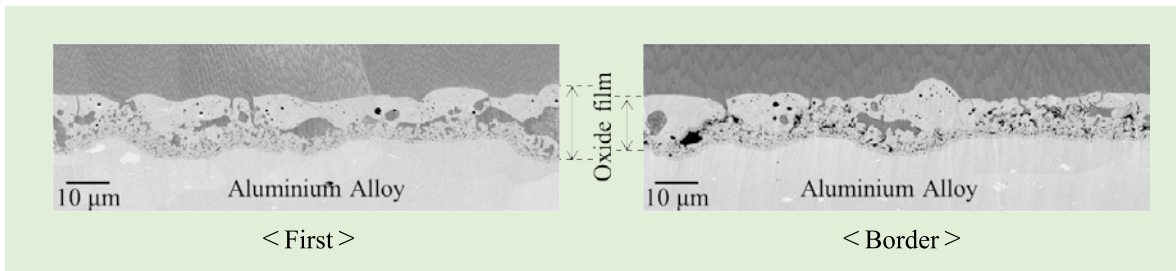
Fig. 9 Cross sectional SEM images of VACAL®-Z oxide film formed by step processing

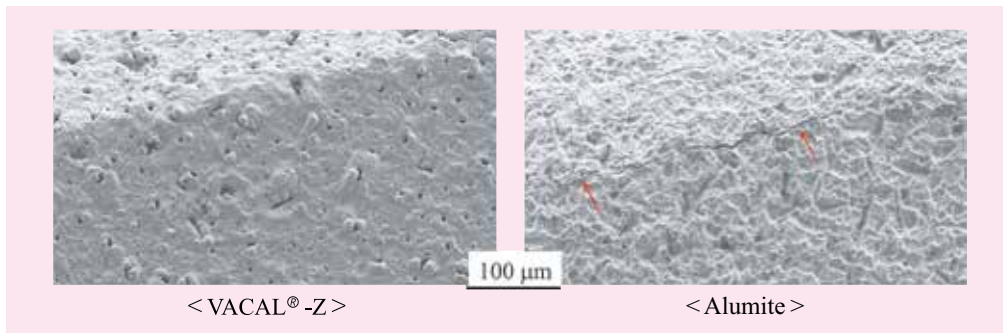
Fig. 10 shows surface SEM images of two corners treated with VACAL[®]-Z treatment and Alumite, respectively.

Fig. 10 Surface SEM images of VACAL®-Z oxide film and Alumite

Cracking is visible on the Alumite corner, whereas the corner receiving the VACAL®-Z treatment was covered with an oxide film. Alumite tends to crack at sharp angles such as corners because the oxide film grows perpendicular to the surface in the depth direction. It is thought that the VACAL®-Z treatment, in contrast, is able to form the oxide film uniformly without cracking, even in the corners, because the oxide film grows by repeated melt and solidification of the Al via electric discharge.

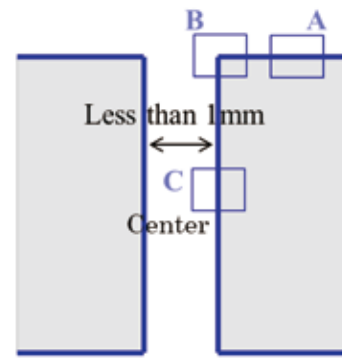
Fig. 11-1 Schematic of fine hole cross section

the oxide film at three locations around a fine hole: the shower plate surface (A), the fine hole opening (B), and the center of the interior of the fine hole (C). Fig. 11-1 shows the locations we inspected and Fig. 11-2 shows the cross-sectional observation results. On the shower plate surface, an oxide film of approximately 15 µm was formed. At the fine hole opening, no cracks were observed on the corner, and an oxide film equivalent to that on the surface was formed. At the center of the interior of the fine hole, an oxide film was formed, but the thickness was about 2/3 that of the surface film. In the VACAL®-Z treatment, an oxide film is formed in proportion to the treatment voltage, and areas where an oxide film is not formed, or where only a thin part is formed, are intensively processed. This is thought to enable the formation of oxide film even in fine holes of Ø1.0 mm or less, which are difficult to treat electrolytically.

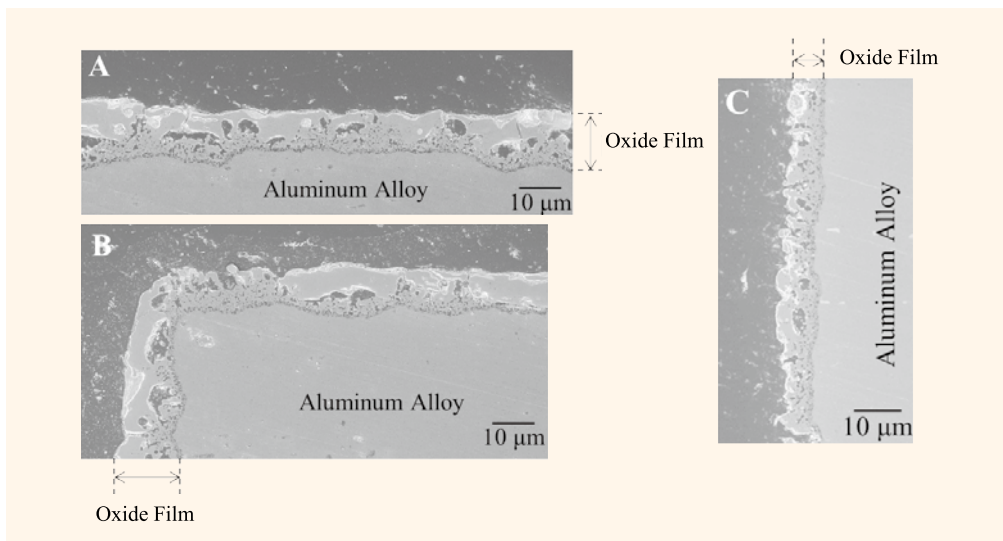
Fig. 11-2 Cross sectional SEM images of various parts of the fine hole
